Silicon Sensor Quality Control for the HGICAL Upgrade of the CMS Detector

Robert Laughlin • Karem Peñaló Castillo • Alexander Wade • Supervising Professor: Rachel Yohay, PHD
Florida State University, Department of Physics

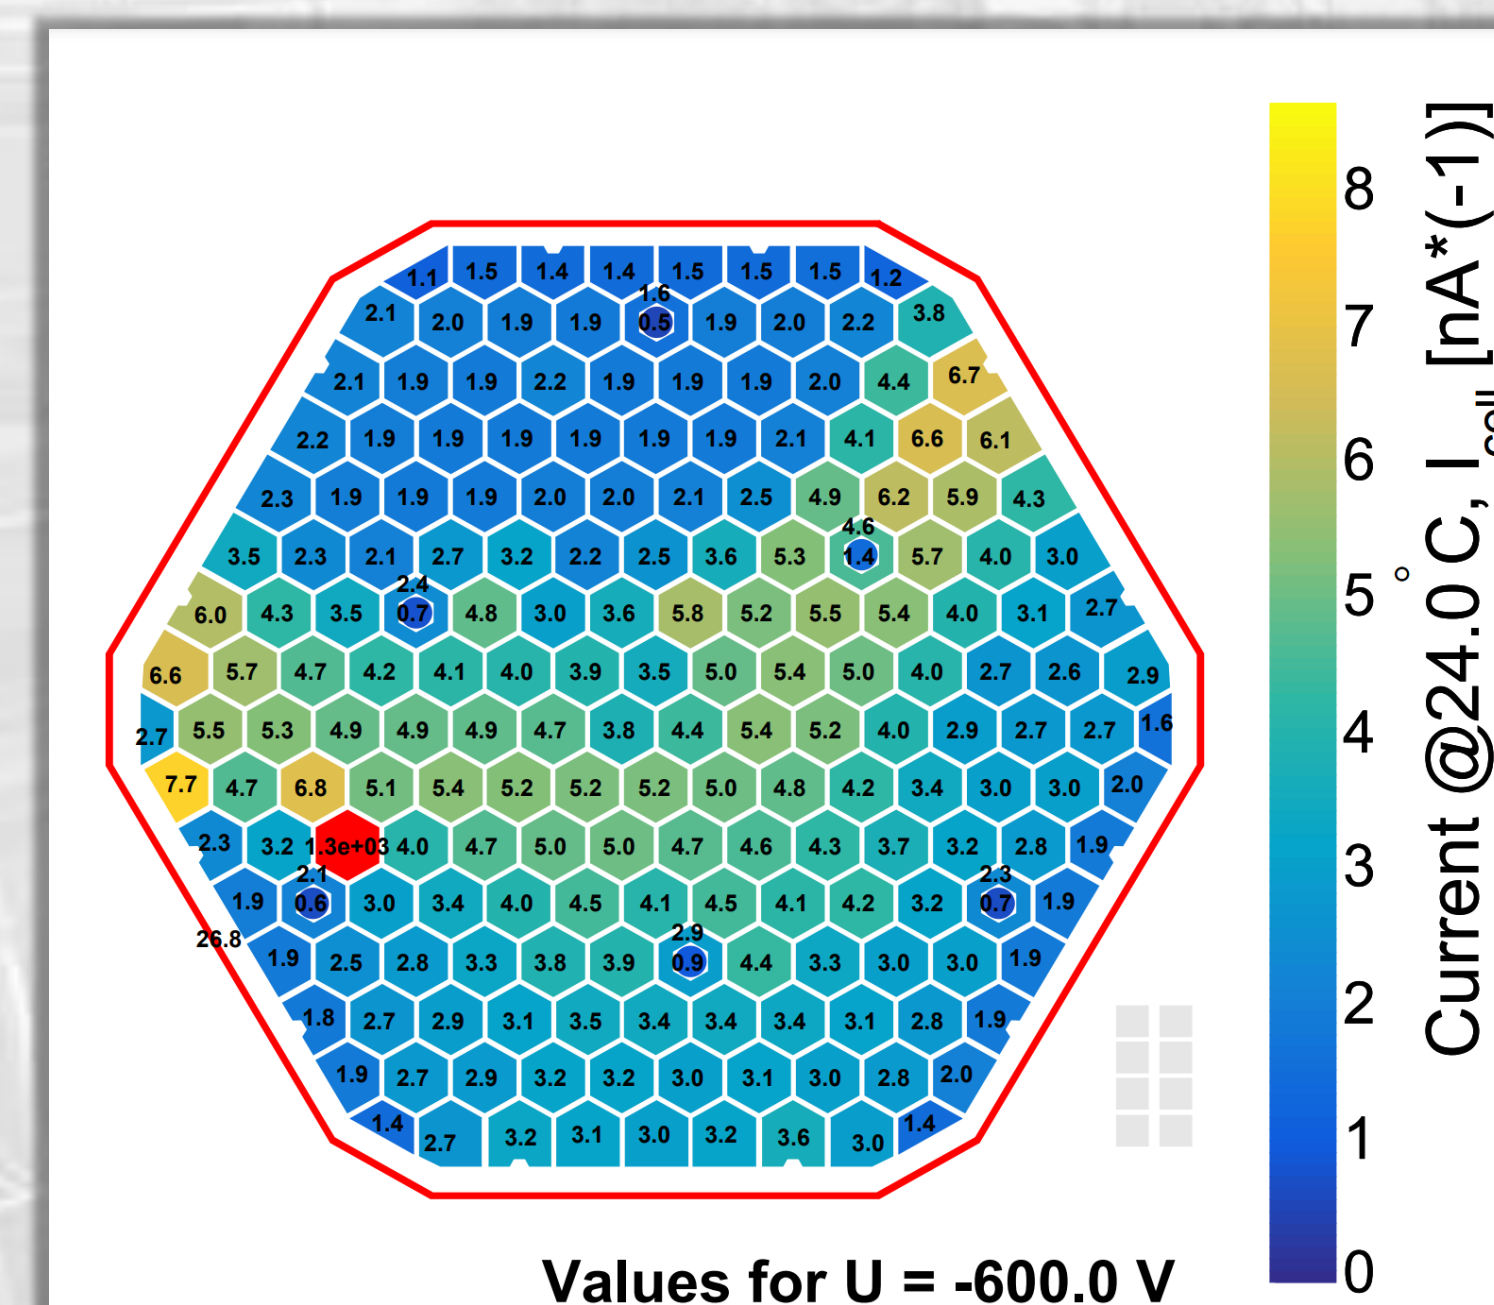
Fig. 2. Hexplot of a low-density sensor from the N_4792 series tested in this research depicting the current read-out on a per-cell basis at a reverse bias of 600 V generated from the automatic analysis after a loop test on the ARRAY probe station.

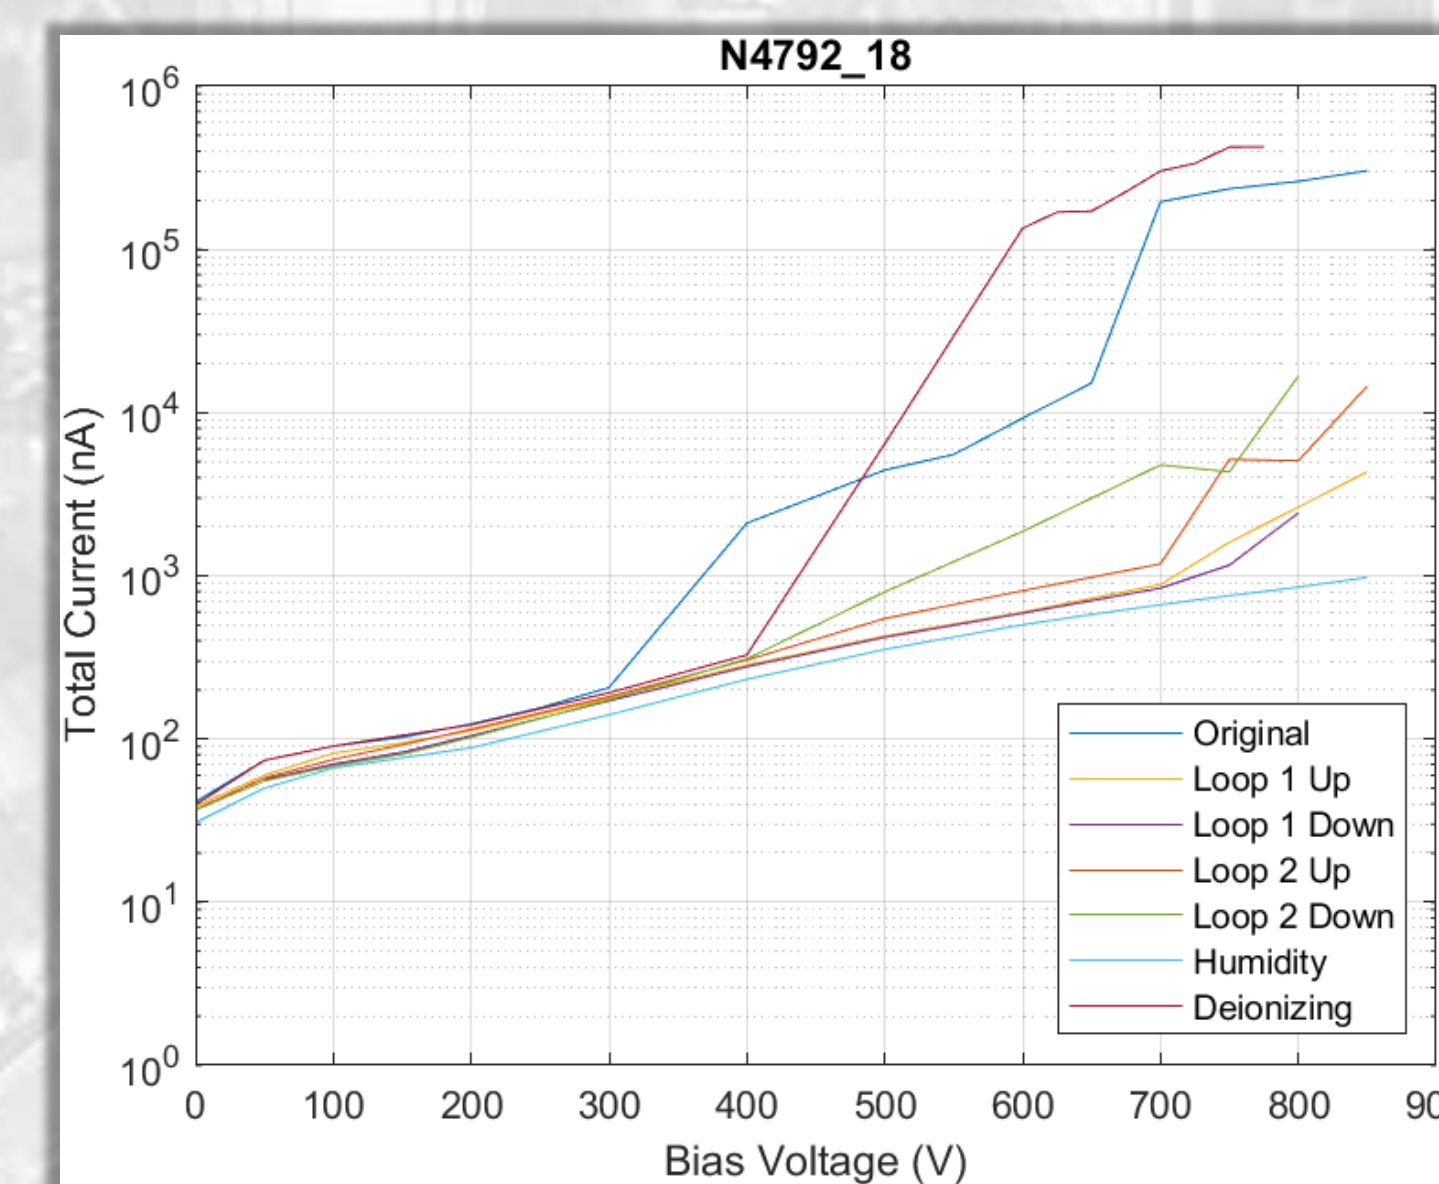
Fig. 4. Results of sensor N4792_18: The total current increases over successive loops at high voltages, and still fails the requirement. The sensor passes the $I(800) < 2.5 \times I(600)$ requirement at low humidity. The sensor hits compliance at 775 V during the deionizing blower test, completely failing the requirement.

The loop test behavior changes over successive tests indicating that the poor behavior of the sensor is related to the amount of handling of the sensor, which possibly indicates charge buildup on the sensor over successive tests. It is notable that in the time between the original test and the loop test, where the sensor remained untouched, the sensor began to behave closer to the expected diode behavior. This could point to handling as leading to the poor sensor behavior.

Our results indicate that the poor sensor behavior goes away when the humidity of the environment the sensors are tested in is decreased to around 8%. This implies that the cause of the poor sensor behavior lies in the environment in which the sensor is tested and not an inherent flaw with the sensor. As the HGICAL will operate in similarly low humidity environment, there is no reason to reject sensors for their poor performance at higher humidity levels.

The deionizing blower appears to not significantly affect the control sensor; however, it has a significant negative impact on failing sensors. This indicates that the failing sensors behavior is related to their ionization, but not in the way we expect.

The corrected behavior at low humidity indicates that future sensor tests should take place in a low humidity environment to differentiate poor sensors from environmental effects.

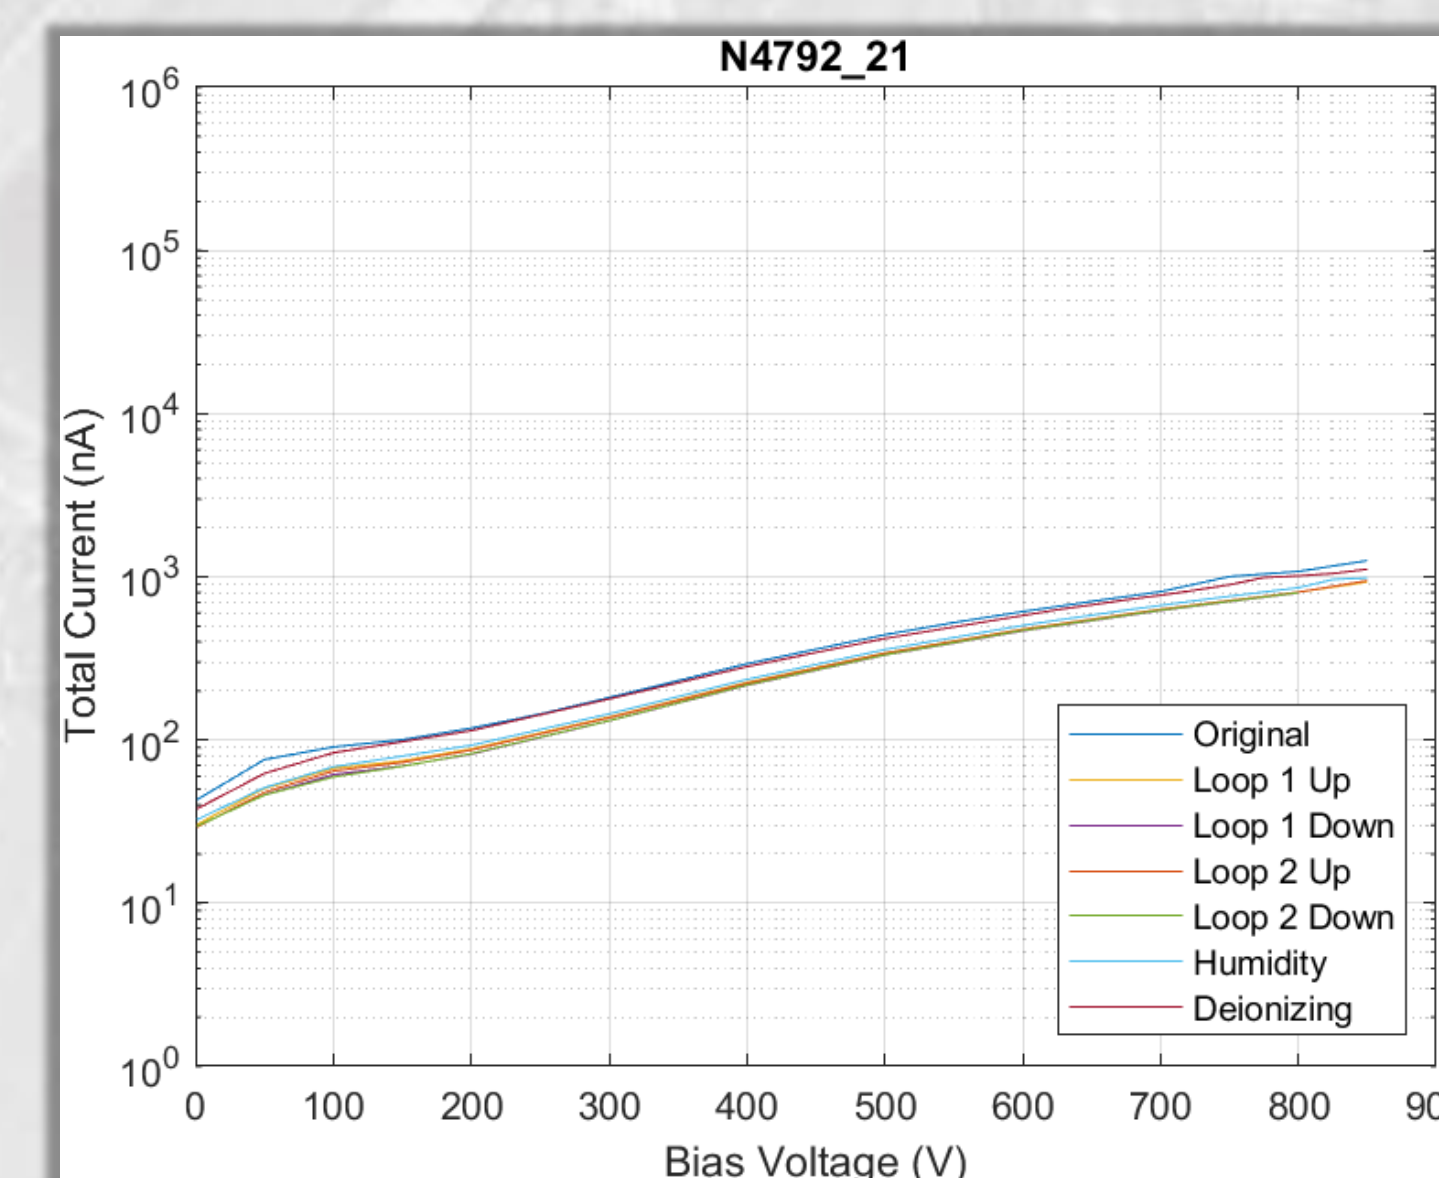
Fig. 5. Results of sensor N4792_21: The control sensor behaves consistently across each test, experiencing only small variation across the different tests. The control sensor meets the $I(800) < 2.5 \times I(600)$ sensor requirement for each test.
